# Situation Photo Log

Thursday, March 1, 2012

Kalamazoo River / Enbridge Spill

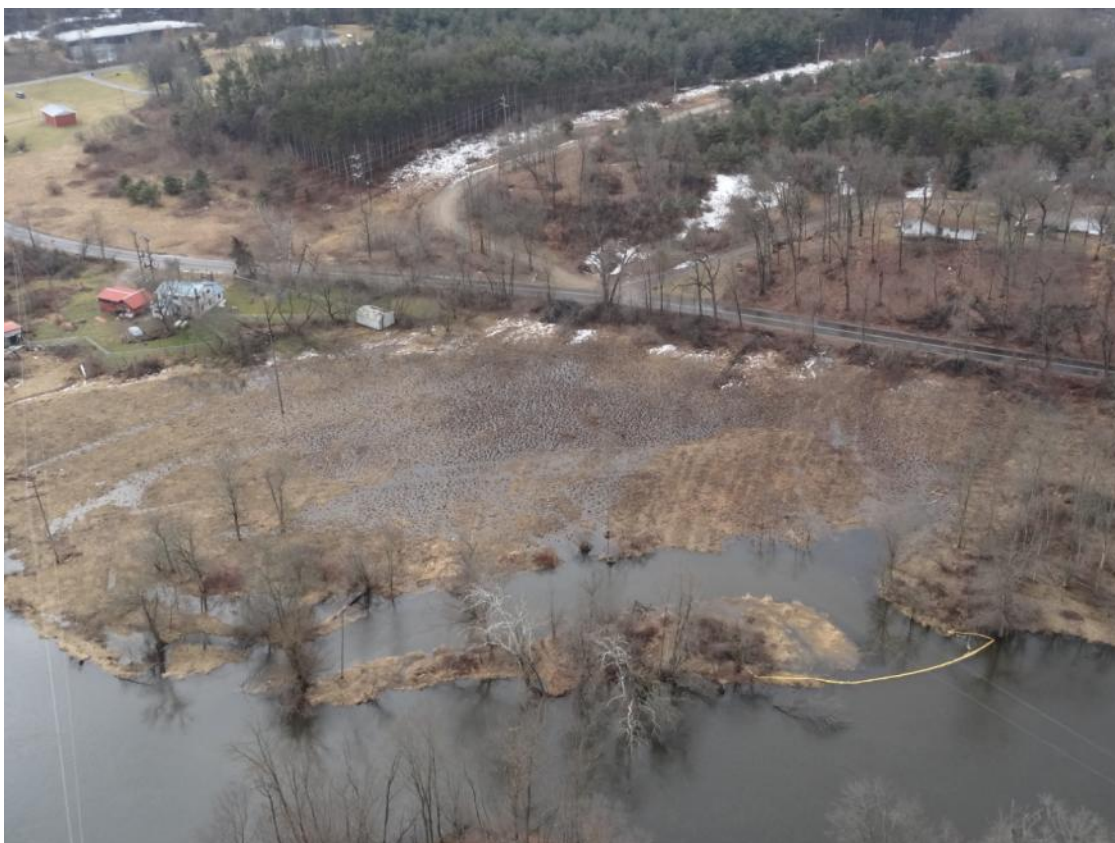
**24. MP10.75 LDB flooding.**

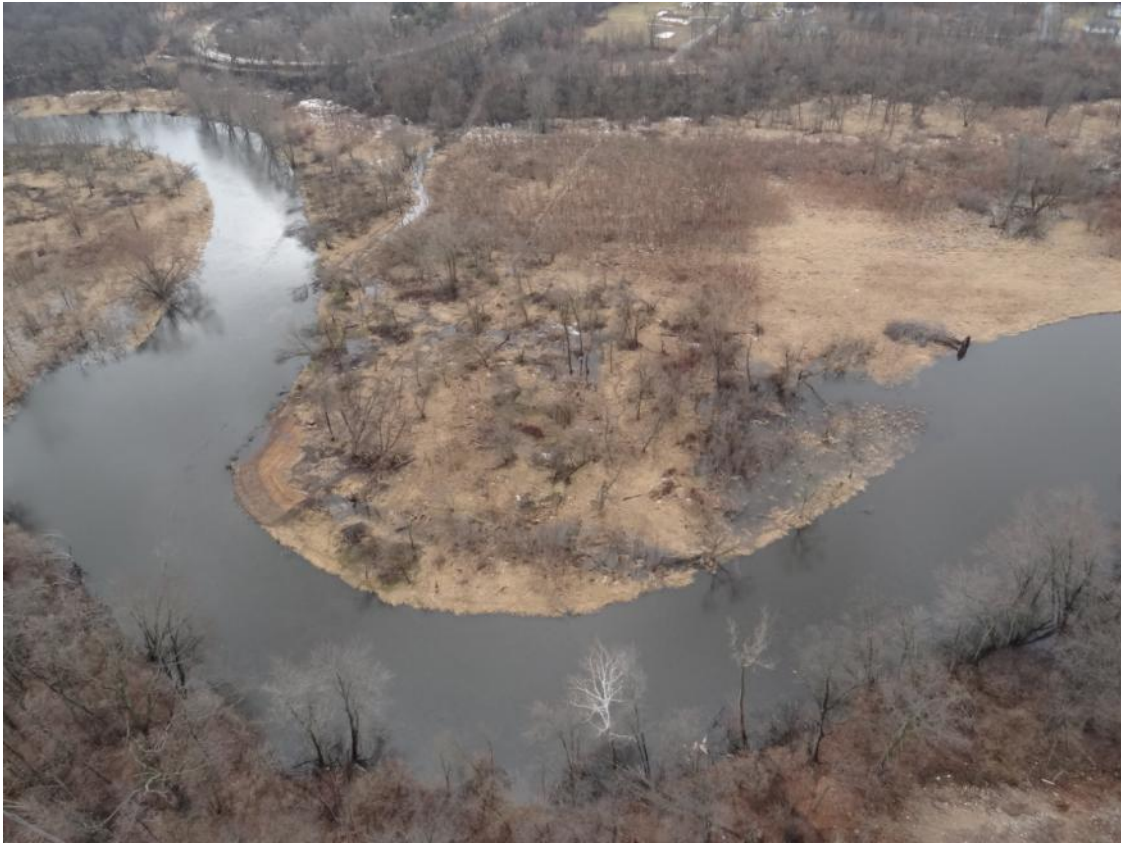
**25. OB13.4 LDB excavation location.**

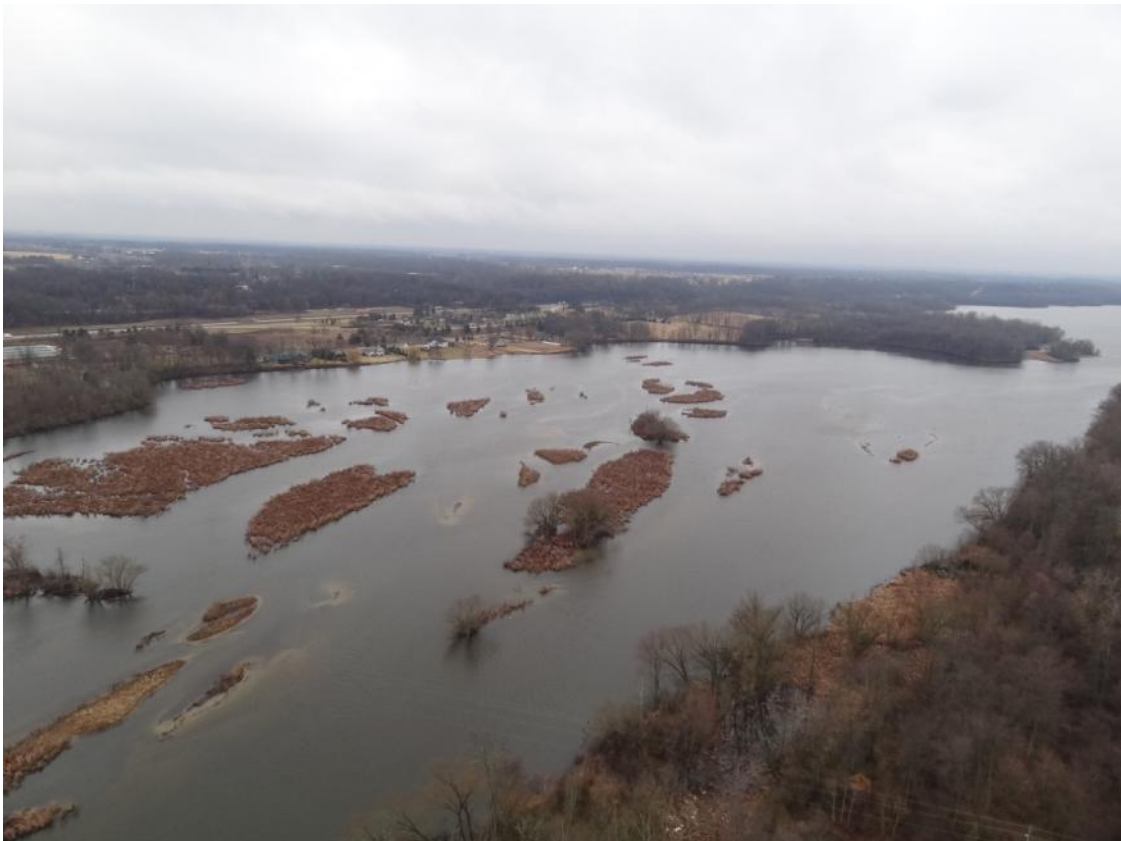
**26. Morrow Lake Delta.**
